TOOLBOX SAFETY TRAINING

Vol 16 - No 26 FALL ACCIDENT

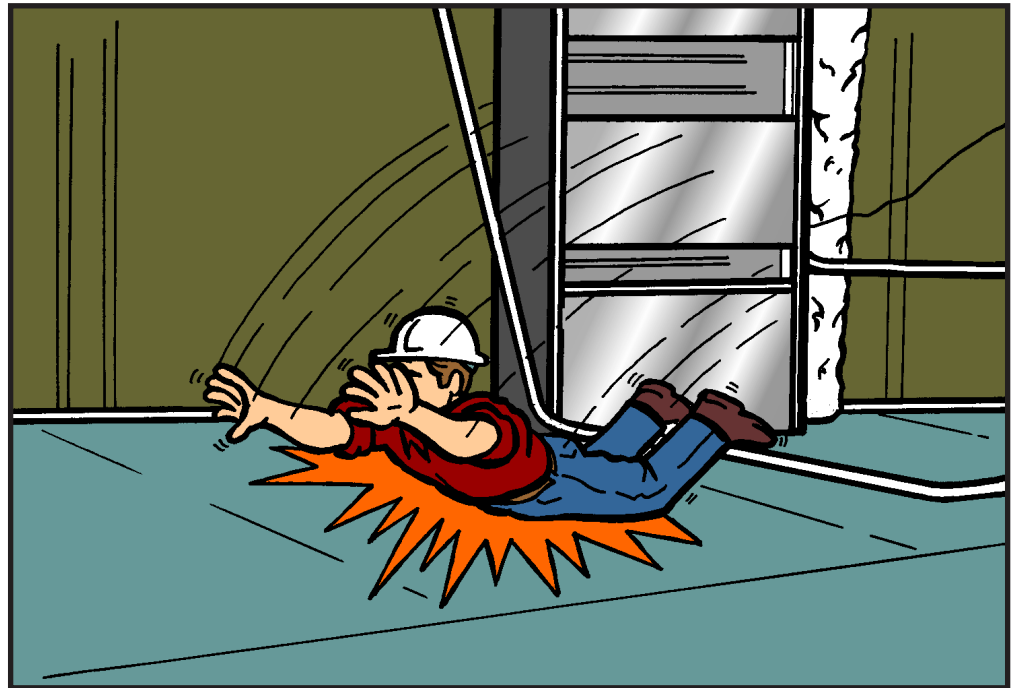
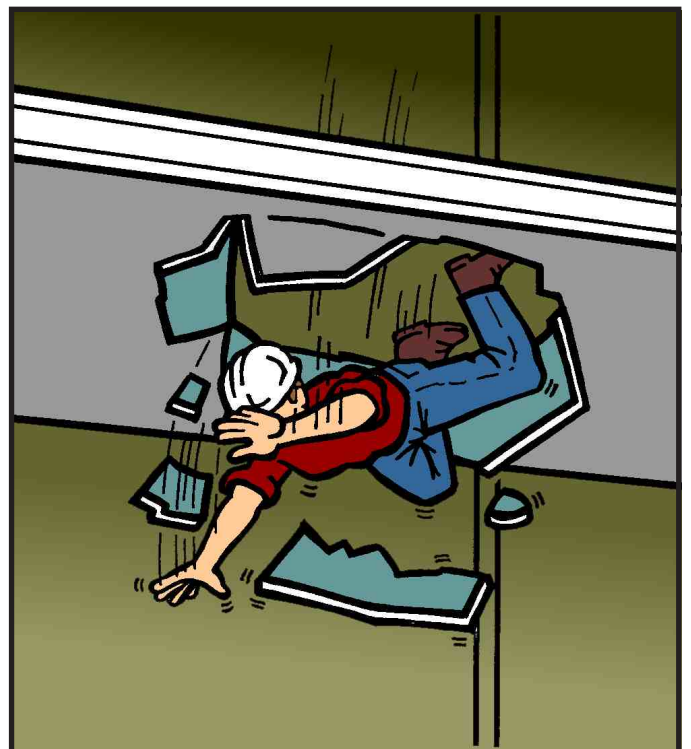
The area is a typical small commercial retail like single story structure constructed of structural steel columns and beams with steel joists and metal decking on the roof. The joists are spaced out at an approximately four (4) to five (5) foot intervals and electrical conduit, alarm and computer wiring also occupy this open space above the ceiling. Unfortunately, when these structures are completed they seldom ever have any LIGHTING fixtures installed. Such was the case for this incident.

As the technician was leaving one work area to examine another area he began to walk (stepping on each joist) across the ceiling. Unfortunately, due to poor (lack of) lighting, the worker did not see a conduit which was run across one of the joists and caused the worker to trip and fall forward through the ceiling tiles and onto the concrete floor below. The worker suffered broken arms and multiple contusions as a result of attempting to "CATCH" himself as he fell.

1. Always survey your work area prior to commencing work for potential hazards such as but not limited to: LIGHTING, proper foundation for walking and weight capacity, electrical hazards and accessibility.
2. Secure the site from any potential overhead hazards to persons potentially working below your work zone
3. LOCK OUT / TAG OUT precautions!
