TOOLBOX SAFETY TRAINING

Vol 16 - No 7 SCISSOR LIFT HOUSEKEEPING

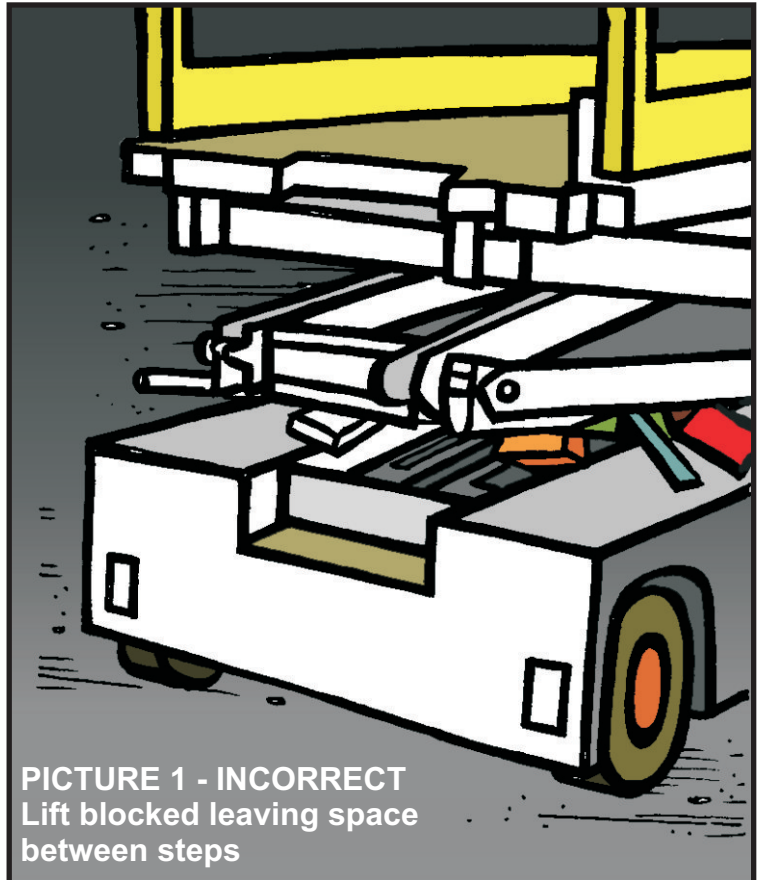
Observance of housekeeping in the work area is a job site requirement. In addition, the inspection of equipment is essential to safe operations. This accident is a result of disregard for both. In April 2007, an employee for an electrical company was installing permanent lighting by connecting flex conduit. The scrap material had gathered up on the wheel base of the scissor lift in use. The employee attempted to set the lift down but he failed to notice that scrap metal from this project and others had gathered at the end of the roller. The hydraulic cylinders which lower the platform run a set of rollers against the wheel base. Because of the trash build up, it failed to set all the way down, leaving a 6" difference on the steps of the lift (Picture 1). An employee attempting to step off the lift was taken by surprise and fell off the back end, injuring his wrist while attempting to break his fall.

PICTURE 1 - INCORRECT
Lift blocked leaving space
between steps

Preventative measures should be taken by inspecting the wheel base of scissor lifts and cleaning debris from previous jobs so as not to cause interference with equipment operations.

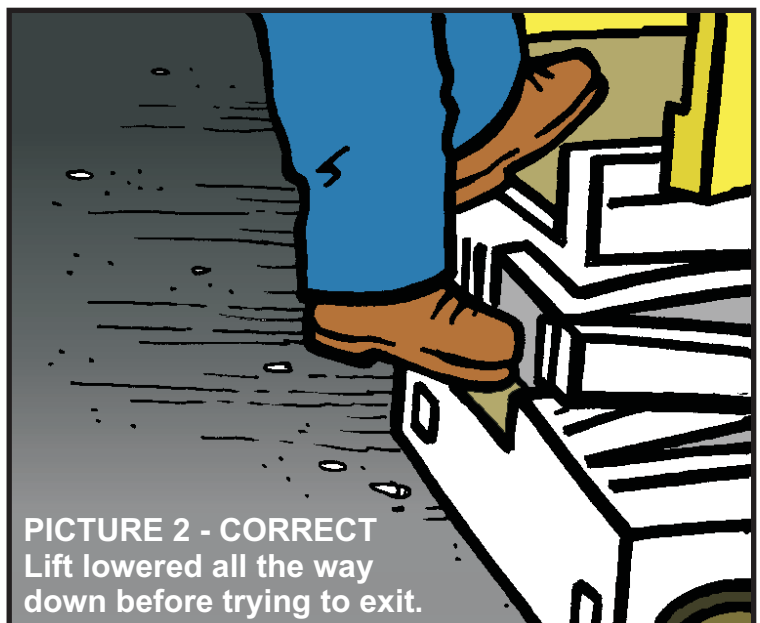
The OSHA standard requires uniform steps on ladders and stairwells. Equipment also needs to meet these requirements (Picture 2). We do not use our eyesight to look at every step we take. Instead, we travel and climb throughout the job site, mostly on muscle memory. When there is a change in elevation, there is usually a misstep causing us to lose our balance and fall.

PICTURE 2 - CORRECT
Lift lowered all the way
down before trying to exit.

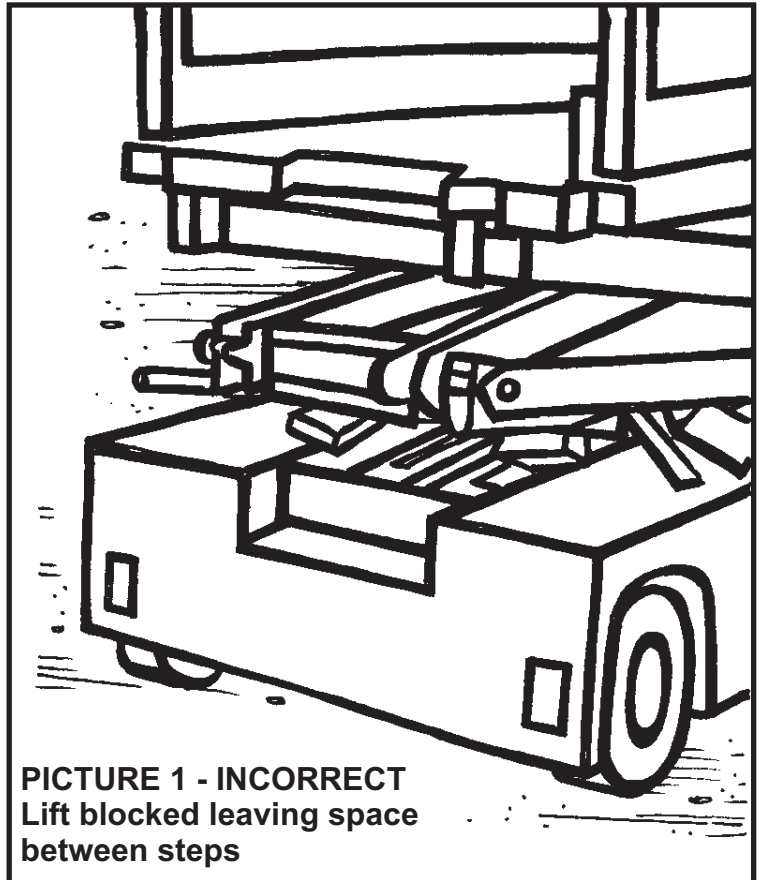
Observance of housekeeping in the work area is a job site requirement. In addition, the inspection of equipment is essential to safe operations. This accident is a result of disregard for both. In April 2007, an employee for an electrical company was installing permanent lighting by connecting flex conduit. The scrap material had gathered up on the wheel base of the scissor lift in use. The employee attempted to set the lift down but he failed to notice that scrap metal from this project and others had gathered at the end of the roller. The hydraulic cylinders which lower the platform run a set of rollers against the wheel base. Because of the trash build up, it failed to set all the way down, leaving a 6" difference on the steps of the lift (Picture 1). An employee attempting to step off the lift was taken by surprise and fell off the back end, injuring his wrist while attempting to break his fall.

Preventative measures should be taken by inspecting the wheel base of scissor lifts and cleaning debris from previous jobs so as not to cause interference with equipment operations.

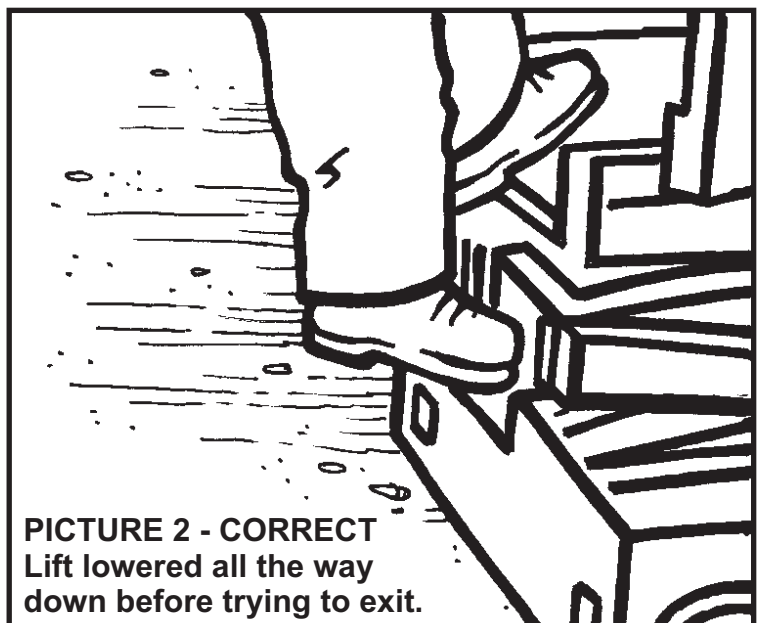
The OSHA standard requires uniform steps on ladders and stairwells. Equipment also needs to meet these requirements (Picture 2). We do not use our eyesight to look at every step we take. Instead, we travel and climb throughout the job site, mostly on muscle memory. When there is a change in elevation, there is usually a misstep causing us to lose our balance and fall.
