TOOLBOX SAFETY TRAINING

Vol 16 - No 26 FALL ACCIDENT

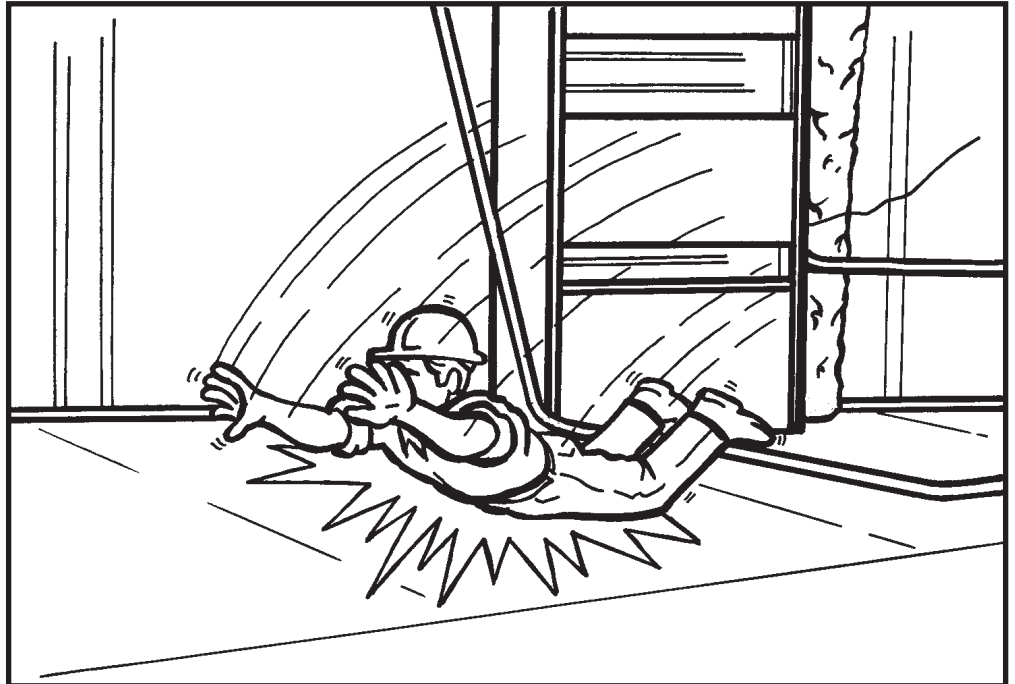
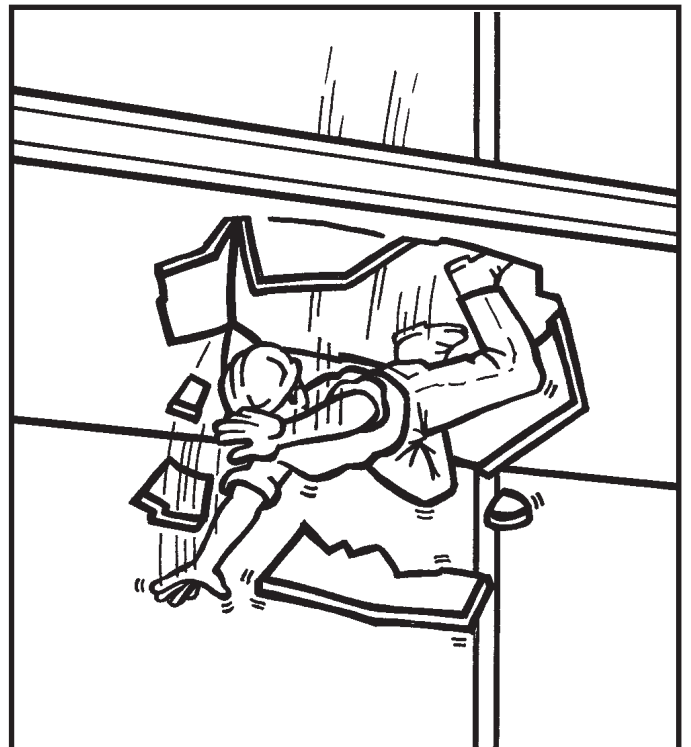
As the technician was leaving one work area to examine another area he began to walk (stepping on each joist) across the ceiling. Unfortunately, due to poor (lack of) lighting, the worker did not see a conduit which was run across one of the joists and caused the worker to trip and fall forward through the ceiling tiles and onto the concrete floor below. The worker suffered broken arms and multiple contusions as a result of attempting to "CATCH" himself as he fell.

1. Always survey your work area prior to commencing work for potential hazards such as but not limited to: LIGHTING, proper foundation for walking and weight capacity, electrical hazards and accessibility.
2. Secure the site from any potential overhead hazards to persons potentially working below your work zone
3. LOCK OUT / TAG OUT precautions!
