# TOOLBOX SAFETY TRAINING

## Vol 16 - No 8 UNBARRICADED TRENCH ACCIDENT

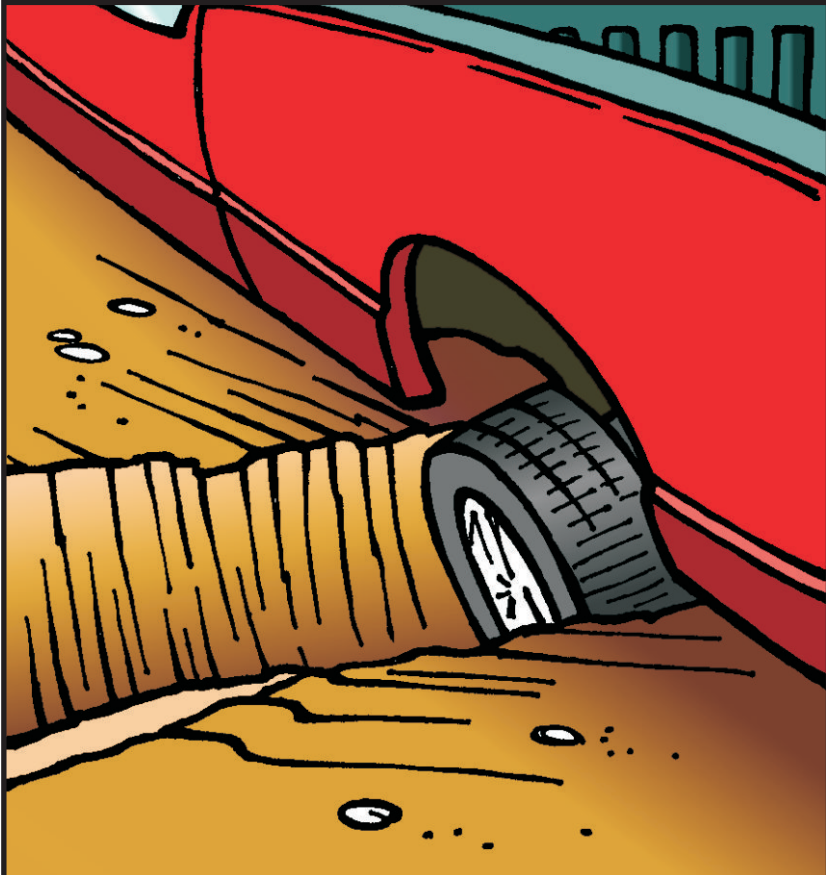
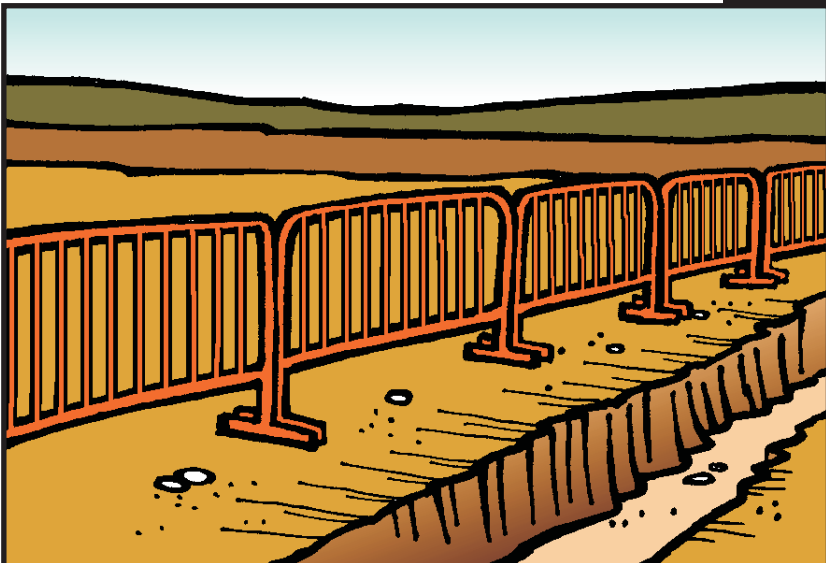
As the Superintendent was driving through the job site, he came across an area that was blocked off by materials and equipment. He decided to back away from the blocked area but did not realize the plumbers had not barricaded a trench they had left exposed as they were waiting for the city inspector to inspect for final approval. The subcontractor that dug the trench had left for the day because the inspector was scheduled to inspect the next day. The superintendent had to have his truck pulled out, rear axle replaced, rear bumper repaired, frame adjusted and could not use his vehicle for three days while it was getting repaired. Estimated costs for repairs were approximately \$3500.00, not including the time it kept the superintendent away from his job.

**1926.651(f) warning system for mobile equipment.** When mobile equipment is operated adjacent to an excavation, or when such equipment is required to approach the edge of an excavation, and the operator does not have a clear and direct view of the edge of the excavation, a warning system shall be utilized such as barricades, hand or mechanical signals, or stop logs. If possible, the grade should be away from the excavation.

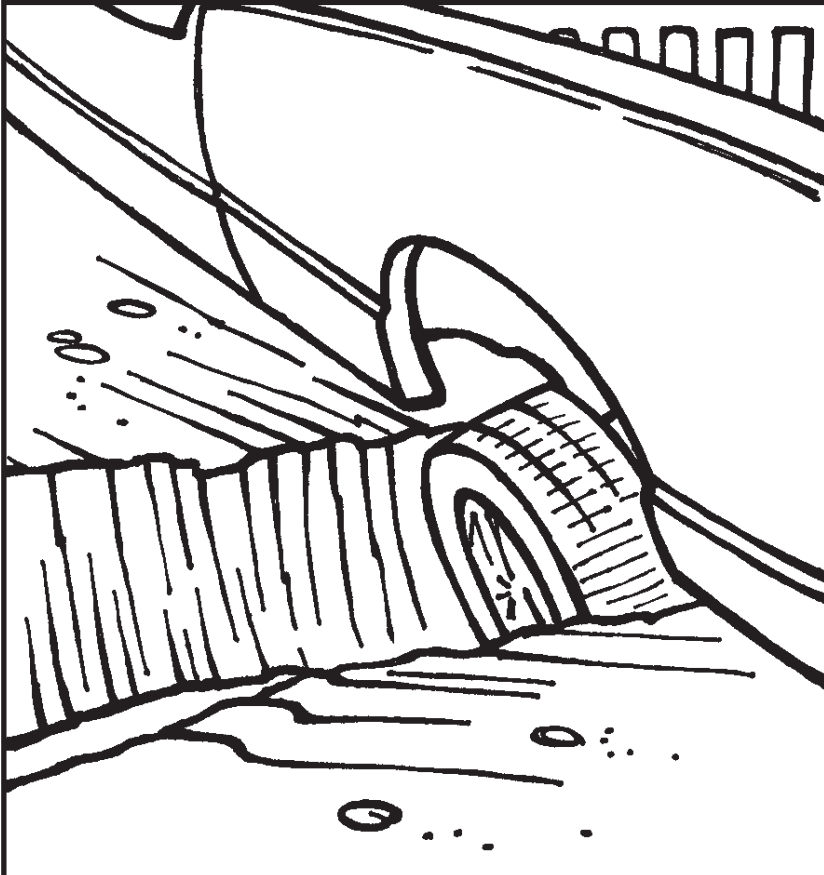
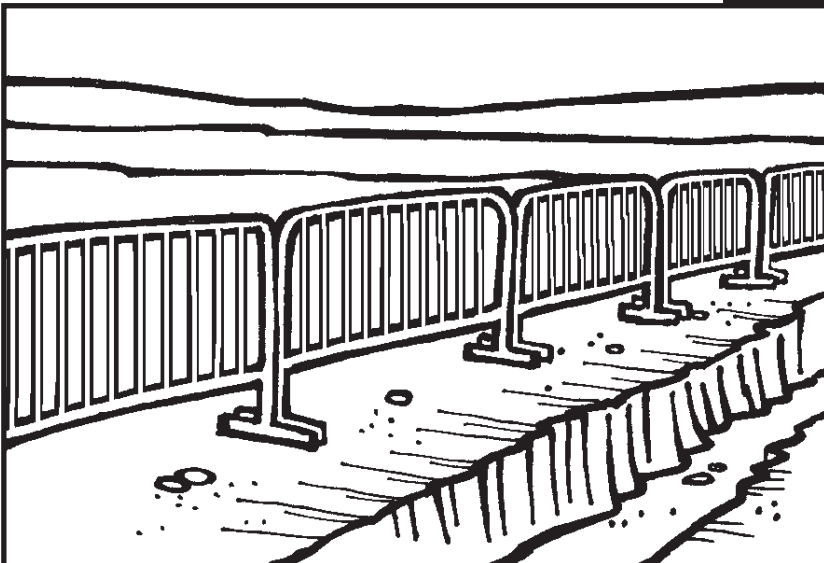
As the Superintendent was driving through the job site, he came across an area that was blocked off by materials and equipment. He decided to back away from the blocked area but did not realize the plumbers had not barricaded a trench they had left exposed as they were waiting for the city inspector to inspect for final approval. The subcontractor that dug the trench had left for the day because the inspector was scheduled to inspect the next day. The superintendent had to have his truck pulled out, rear axle replaced, rear bumper repaired, frame adjusted and could not use his vehicle for three days while it was getting repaired. Estimated costs for repairs were approximately \$3500.00, not including the time it kept the superintendent away from his job.

**1926.651(f) warning system for mobile equipment.** When mobile equipment is operated adjacent to an excavation, or when such equipment is required to approach the edge of an excavation, and the operator does not have a clear and direct view of the edge of the excavation, a warning system shall be utilized such as barricades, hand or mechanical signals, or stop logs. If possible, the grade should be away from the excavation.
